A Study of the Internal Diesel Injector Deposit Phenomenon

Robert Quigley, Robert Barbour, Emma Fahey
Lubrizol Limited, Derby, UK

Summary

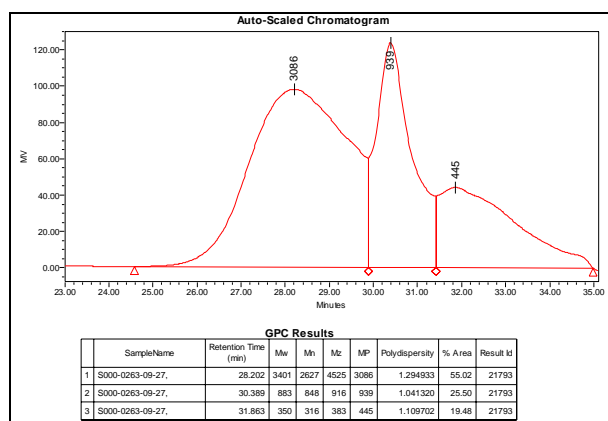
A GPC chromatograph obtained from the product of mixing and heating between succinimide 1 and dimer acid is shown in Figure 1. It shows a peak of significant intensity (939 Mp) attributable to dimer acid, while a broader peak at 3086 Mp is around 1000 molecular weight units higher than the starting PIB succinimide and is possibly a 1:1 adduct of succinimide 1 and dimer acid.

Figure 1 Chromatograph of succinimide 1 and dimer acid mixture after stirring and heating.

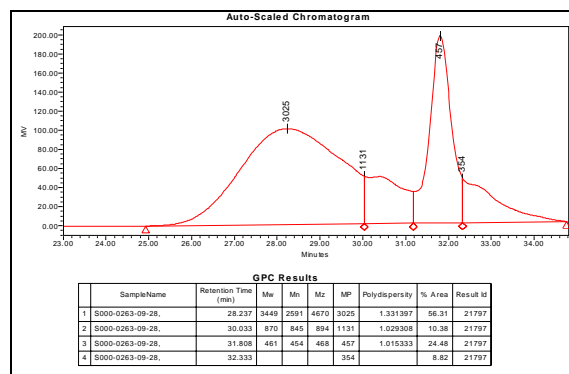
Figure 2 shows the GPC chromatograph of the reaction product between succinimide 1 and mono-carboxylic acid lubricity improver. A large peak at 457 Mp appears to indicate a large fraction of unreacted mono-fatty acid. A broad peak also occurs at 3025 Mp, which may be a 1:2 adduct of succinimide 1 and mono-fatty acid.

Figure 2 GPC chromatogram of succinimide 1 and mono-carboxylic fatty acid mixture after stirring and heating.

In summary, chromatographs of all three mixtures obtained following heating and stirring runs between succinimide 1 and the lubricity improvers showed substantial peaks associated with unreacted fatty acid or ester, along with some evidence of adduct formation in all three cases.

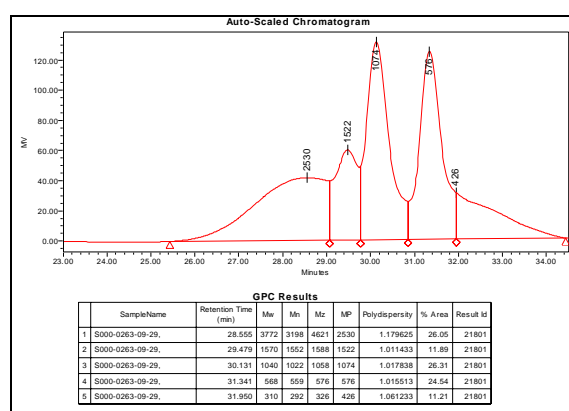
Figure 3 shows a chromatograph of the mixture of succinimide 1 and glycerol fatty acid ester lubricity additive after heating and stirring. Peaks attributable to the mono-, di- and tri-glycerol esters of fatty acid are apparent, along with a higher molecular weight peak at 2530 Mp, which may be an adduct between the succinimide and fatty acid derived from the the glycerol oleates.

Figure 3 GPC chromatogram of succinimide 1 and glycerol esters mixture after stirring and heating.

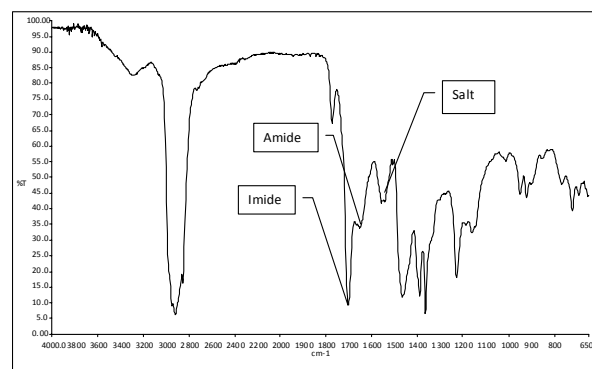
The FTIR spectrum of the reaction product between succinimide 1 and dimer acid, which appeared to be the mixture that showed the most interaction of those tested, is shown in Figure 4. The spectrum of the heated mixture shows similar levels of imide and amide functionality, as would be found in the neat succinimide itself (Figure 5). The main functional difference is the increase of an absorbance characterised by ammonium salt formation with the dimer carboxylic acid at 1560 cm⁻¹. Although there may be some broadening of the amide absorbance, there is little evidence of significant levels of amide formation between the dimer acid and the succinimide. Therefore, the likely reason for the formation of the extremely viscous adduct between succinimide 1 and the dimer acid is dimer cross linking primarily through ammonium carboxylate salt formation, probably also with a lesser degree of amide formation. The predominant

imide absorbance of the succinimide functionality at 1700 cm⁻¹ remains prominent in the infra-red spectrum of the reaction product. This is a particularly significant difference compared to the IDID spectra presented by Ullman *et al.*[1, 4]

Figure 4 FTIR of succinimide 1 heated with dimer acid for 180°C for six hours.

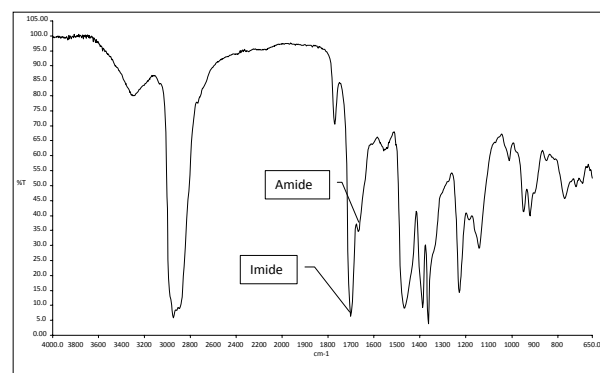
Figure 5 FTIR spectrum of succinimide 1.

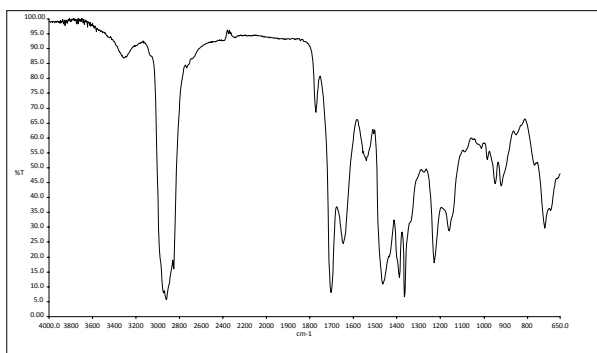
The FTIR spectrum of succinimide 1 mixed and heated with the mono-acidic lubricity improver is shown in Figure 6 and reveals absorbances that are due to carboxylic acid salt formation (1560 cm⁻¹), imide (1700cm⁻¹) and amide (1660 cm⁻¹). It would appear that the intensity of the amide absorbance has increased following heating. The imide absorbance remains similar in intensity to that found with the neat succinimide 1, indicating that this functionality has not formed substantial amounts of amide with the dimer acid. Overall therefore, the effect of mixing and heating succinimide 1 with mono-acidic lubricity improver seems to result in an increase of both carboxylic acid salt and amide functionalities, with maintenance of imide absorbance.

Figure 6 FTIR spectrum of succinimide 1 mixed and heated with mono-acidic lubricity improver.

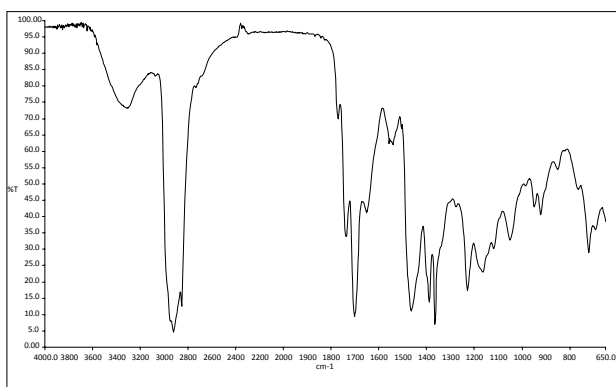
The FTIR spectrum of the mixture of succinimide 1 and glycerol ester is shown in Figure 7. Once again, absorbances due to amide, imide and carboxylic functionality are evident, along with an absorbance arising from the ester functionality of the lubricity improver.

Figure 7 FTIR spectrum of succinimide 1 mixed and heated with glycerol fatty acid ester lubricity improver.

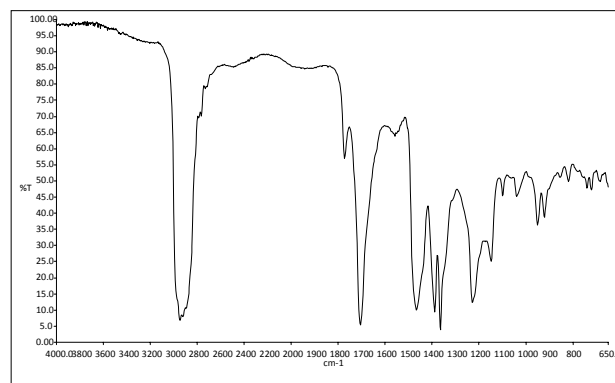
Figure 8 illustrates the FTIR spectrum of succinimide 2 with dimer acid and shows the presence of imide and carboxylic acid salt only. Because succinimide 2 contains only tertiary amine, it cannot react to form an amide with carboxylic functionality and this is borne out by the infra-red spectrum. Similar conclusions can be made for the FTIR spectra of the reaction products between succinimide 2 and the mono-acidic and ester lubricity improvers.

Figure 8 FTIR spectrum of succinimide 2 heated and mixed with dimer acid.

In summary of the findings from these mixing and heating experiments, the most significant effects were found with the dimer acid, with which both succinimide 1 and 2 formed highly viscous materials. Most of this increase in viscosity could be attributed to salt formation, with some possible amide formation in the case of succinimide 1. In the case of succinimide 2, only salt formation is possible and no amide absorbances are evident. In all cases, a very strong imide absorbance is maintained after the reaction period.

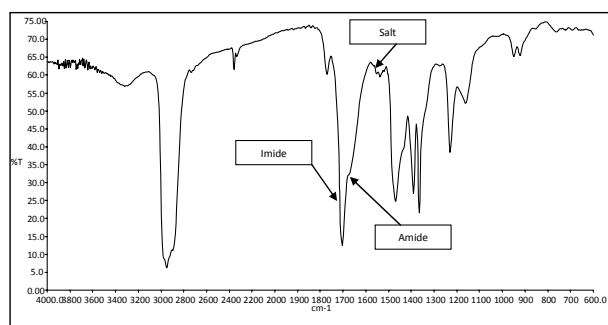
Examining firstly the FTIR spectrum of the reaction carried out in the absence of formic acid, as shown in Figure 9, the ratio of imide to amide appears to be very similar to that of the unreacted succinimide, suggesting that no increase in amide levels occurred during the reaction. Note that this spectrum does appear very similar to that of the unwashed reaction product.

Figure 9 FTIR spectrum of succinimide 1 and dimer acid mixture after heating washed with dichloromethane.

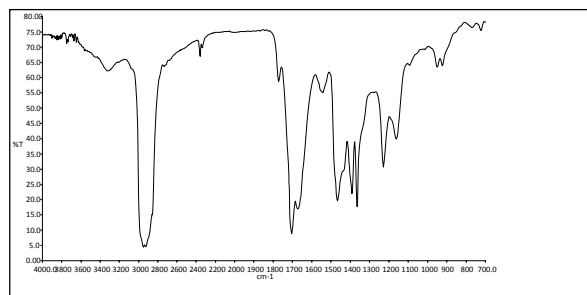
Figure 10 shows the infra-red spectrum of the combination of succinimide 1, dimer acid and formic acid, following washing. Once again, there was no appreciable difference between spectra of unwashed and washed samples. Compared to reaction without formic acid, more amide does appear to have formed, which would be regarded as unsurprising, but imide functionality still appears to predominate. Despite the advised change in reaction conditions, spectra of the reaction products with and without formic acid do not closely resemble those of internal injector deposits reported by Ullmann *et al.*

Figure 10 FTIR spectrum of reaction product of succinimide 1, dimer acid and formic acid washed with dichloromethane.

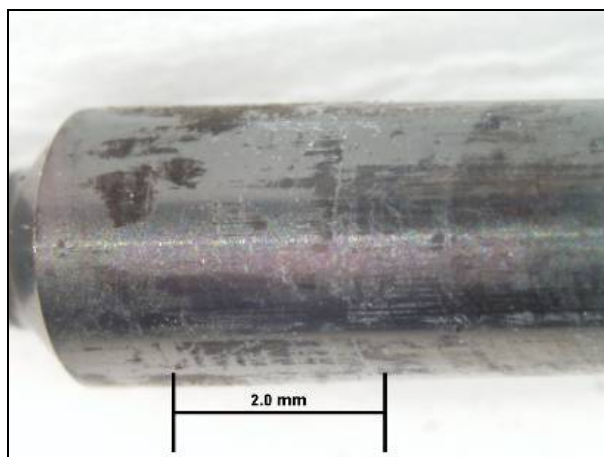
This section describes the results of analysis of failed fuel injectors from the engines of several North American heavy duty OEMs which have been noted [9] to have a consistent chemical composition of the “soap” type, perhaps different than those observed in Europe. The first set of injectors were taken from a recently introduced Tier 2 common rail engine model manufactured by OEM 1, which had been experiencing unacceptable rates of injector failure in different applications and locations. Failed injectors recovered from engines in two different geographical locations and engine applications were analysed. A single blocked filter from one of the locations was also submitted. A section from a needle from one of the failed injectors is shown in Figure 11.

Figure 11 Image of failed injector from OEM 1 Tier 2 engine.

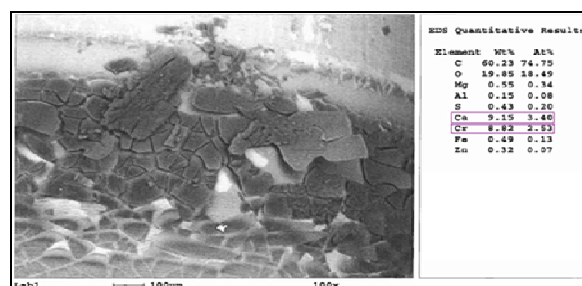
Deposits on the injector needle and piston from the OEM 1 engine model were first examined using scanning electron microscopy (SEM) and energy dispersive spectroscopy (EDS). The analysis showed that the elemental composition of the deposits predominantly consisted of carbon and oxygen. Relatively large amounts of calcium (around 9% by weight) were also found, but not large amounts of zinc, sulphur or phosphorus. The EDS quantitative results are shown in Figure 12 (and Table 6). Note that the appearance of iron and chromium are an artefact of beam penetration to the metal surface of the injector.

Figure 12 EDS image and quantitative analysis of injector deposit from OEM 1 needle.

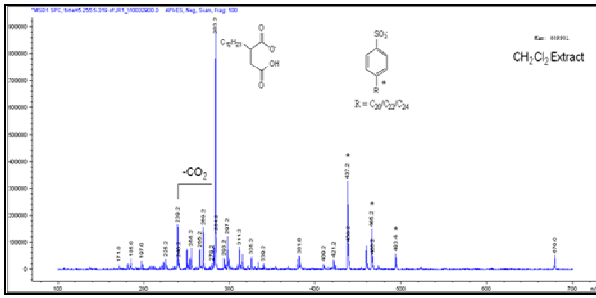
The deposit was extracted into dichloromethane and the result ESI mass spectrum is shown in Figure 13. The scan shows the presence of residues attributable to dodecyl succinic acid (DDSA) and alkylbenzene sulphonate. Residues attributable to dimer acids, fatty acids or succinimide deposit control additives were not detected. However, it should be noted that chemical species present in the injector deposit need to be soluble in the extraction solvent and polar in order to be detected by the ESI-MS method.

Figure 13 ESI mass spectrum for internal injector deposit extracted in dichloromethane.

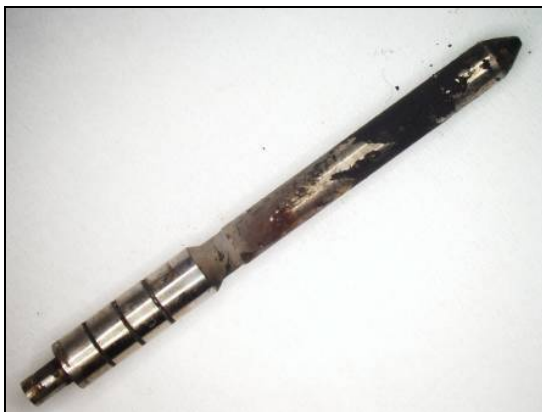
Five failed injectors from a second OEM’s engine model were also submitted for analysis. The affected injectors were fitted to Tier 3 common rail diesel engines in two different geographic locations. These were reported to have suffered from “sticking” and had been returned to dealerships. For comparative purposes, a non-sticking needle was also obtained. The needle from one of the sticking injectors is shown in Figure 14.

Figure 14 Image of sticking injector from OEM 2 Tier 3 common rail engine.

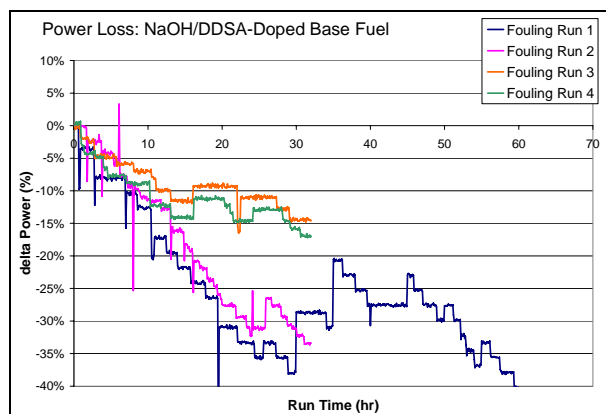
Initial test runs with the engine were carried out using fuel dosed with a stoichiometric blend of sodium hydroxide and dodecyl succinic acid (DDSA), thereby capable of producing the sodium salts of the DDSA. The results from four such runs are charted in Figure 15. In all four tests, engine power dropped very considerably during operation. This corresponded to decreasing exhaust temperatures (Figure 16).

Figure 15 Engine power versus test run time using ULS fuel dosed with sodium hydroxide / dodecyl succinic acid. (Four test runs are charted.)

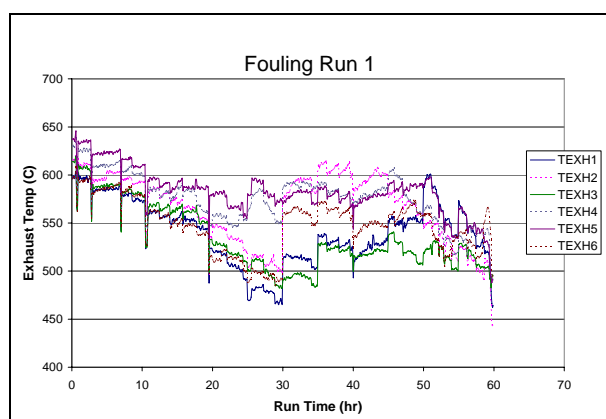
Figure 16 Engine exhaust versus test run time during Fouling Run 1.

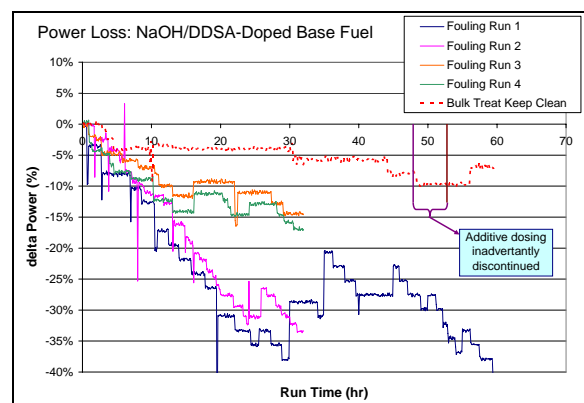
in this engine. The engine was therefore run with the sodium-DDSA salt dosed fuel, but was also treated with a constant use treatment level of the deposit control additive that had been shown to successfully remove internal deposits in the field. The results from this test are shown in Figure 17. The effect of the deposit control additive treatment is clearly to prevent the power loss that was observed in the repeated runs with the base fuel containing the sodium-DDSA salt only. Note that engine power started to decline at around forty-eight hours into this run, which was due to inadvertent discontinuation of the deposit control additive dosing. Exhaust temperatures (Figure 18) were also maintained by the keep clean dose of additive.

Figure 17 Engine power versus test run time using ULS fuel dosed with sodium hydroxide / dodecyl succinic acid and deposit control additive at "keep clean" treat rate. (The four initial runs without DCA are also charted for comparison.)

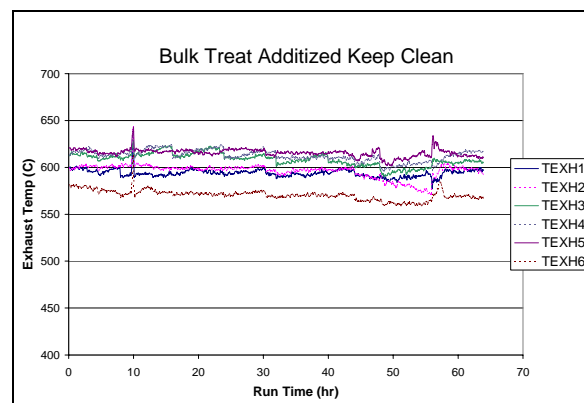
Figure 18 Engine exhaust versus test run time during additized deposit control test.

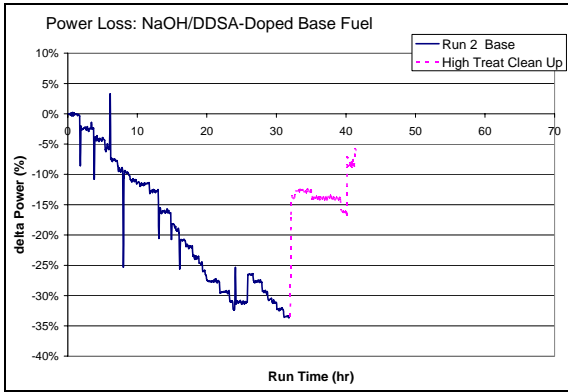
A final test intended to duplicate OEM experience in the field consisted of an attempt to remove pre-existing deposits from one of the fouled injector sets. Once again, the test was carried out with ultra-low sulphur diesel fuel treated with the sodium-DDSA salt, but in addition, after 32 run-hrs of deposit build up, a high treat dose of the same deposit control additive was added to the fuel. The result of this test is charted in Figure 19, where the plot of engine power versus test cycle shows a very rapid restoration of engine power.

Figure 19 Engine power verses test run time using ULS fuel dosed with sodium hydroxide / dodeceny succinic acid and deposit control additive at “clean up” treat rate.

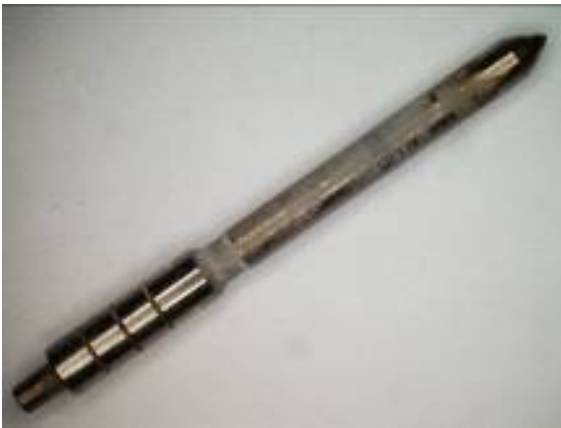
Injectors from the demonstration engine tests were analyzed as before, summarized in Table 9. There are several observations to be made from the results. First, the composition of the deposit is consistent that seen in field injectors with respect to the presence of sodium and DDSA in the deposit. Second, it should be noted that while there are many similarities between the deposit compositions of base and additized runs, the deposit in additized tests was much thinner and was present on a much smaller area of the injector (Figures 19 and 20).

Figure 19 Base fuel fouling run injector needle.

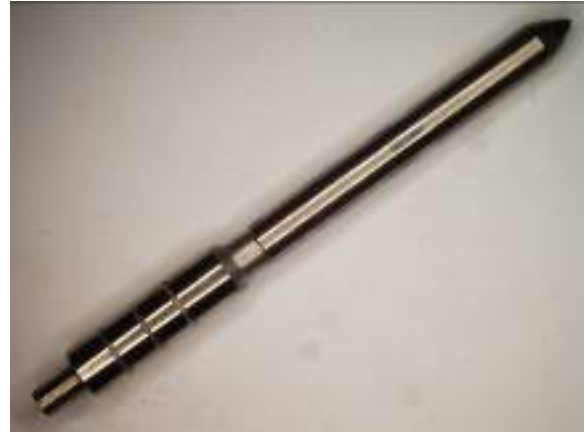
Figure 20 Additized ‘keep clean’ run injector needle
